PROFESSIONAL BOATBUILDER

Return to *Unexpected*

We revisit a sportfisherman that we profiled a few years ago, to see how its paper-honeycomb-cored interior has performed in service.

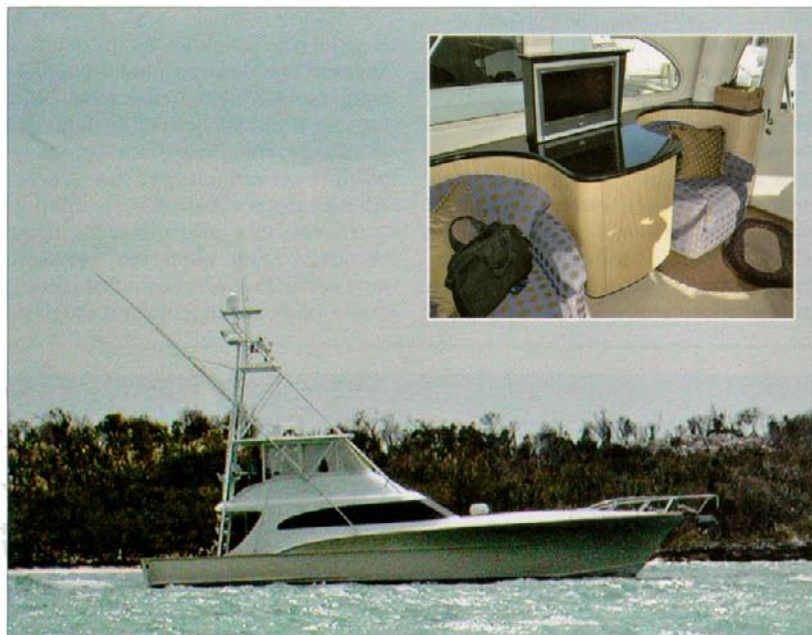
The honeycomb-cored interior joinery on the 61' (18.6m) high-speed sportfisherman, built by its owner, Kirk Evans, weighs about one-third of what a similar interior built in plywood or MDF would weigh. **Inset**—One of the many curved modules in the saloon.

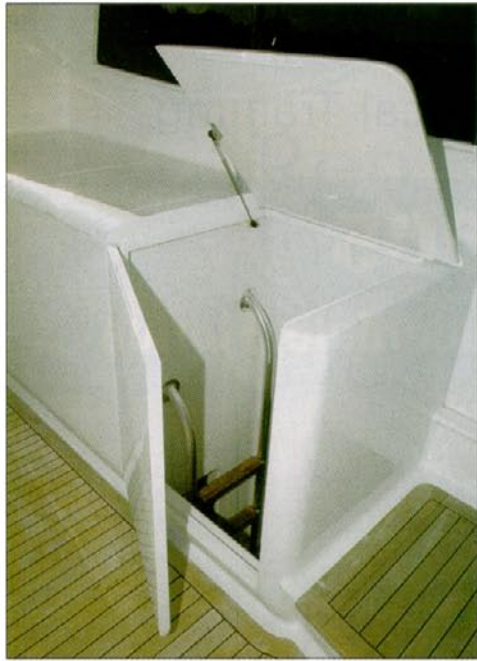
Far left—Unexpected's engineroom is accessed through a solid door front and a cored horizontal hatch. **Left**—Drilling additional shelf support-pin holes in the installed panels proved difficult, so Evans added support posts to the cabinet sidewalls underneath the shelves.

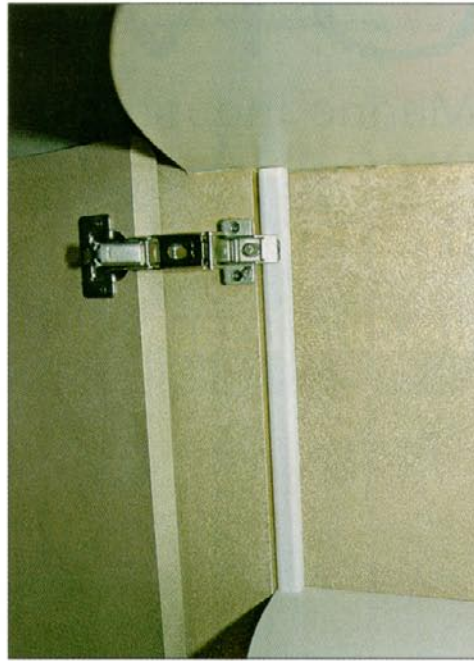
As we were provisioning the boat at the start of the tournament, Evans told me, "My biggest overall goof in interior construction was that I didn't install rails into the honeycomb-cored cabinet sidewalls for the shelf-support pins. Sue and I selected what we thought were the correct heights for the shelves, and that's where I drilled holes through the veneers and into the honeycomb. I dug out the honeycomb around the hole, masked it off, and then filled the hole with epoxy. After the epoxy cured I re-drilled it, inserted the shelf-support pins, and we were good to go. No problems at all with the holes I made.

"Things were fine until we started storing some oddball-sized containers in the cabinets, and decided that we wanted more shelf positions. But potting the holes with epoxy, which was easy to do when the cabinets were disassembled and I could lay the panels down flat, is a messy horror show when the panels are vertical. I wish I had let-in bars of hardwood or PVC board so that there'd be something solid to drill into for securing the pins. At the moment, that's at the top of my 'I won't do it that way again' list. My solution was to attach support posts underneath the shelves to the cabinet sidewalls."

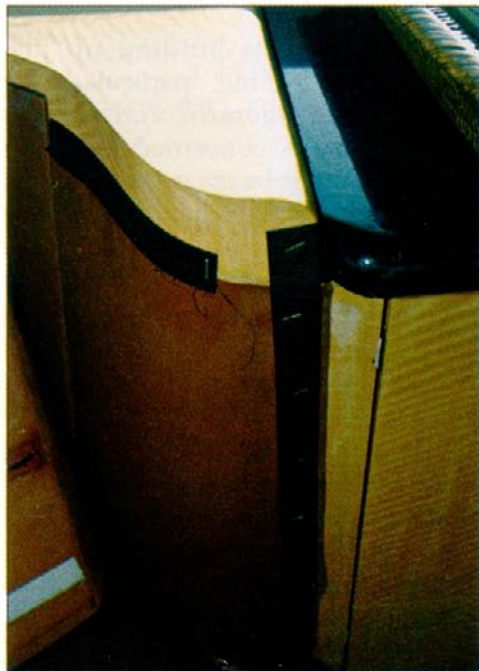
Left—The contact adhesive securing the Velcro tapes to the joinerwork and fabrics has gradually failed, allowing slight puckering between the staples. **Above**—The domestic-style drawer slides, let into the honeycomb panels here on the freezer units and elsewhere, are working well.

Sue Evans pointed out another shortcoming of the upholstery to me as she removed cushions from the saloon seating so I could photograph its interior. "At first, the Velcro-hook sections that were stapled and glued to the furniture were secure, but then, as the hot days added up, the adhesive started to fail. That made for a sticky perimeter of adhesive goo around the tapes. I've investigated quite a bit, and have found two likely fixes. One is a Velcro product with a high-temperature-rated contact adhesive on

pounding each one in individually with a hammer, supporting the surrounding area with a heavy metal backing plate. Next time around I plan on devoting more time and thought to building modules that are easier to fasten upholstery and Velcro to. I don't think these changes will add much weight, and any extra time I spend on building them will be more than recovered when the foam and fabric are applied to the joinerwork."

the back. It's good to about 180°F [82°C]. The alternative is glue-it-yourself Velcro tape and a high-temperature-tolerant contact adhesive. I suppose there's a third way, where the Velcro tapes are sewn onto the fabric or leather covering that's glued to the furniture."

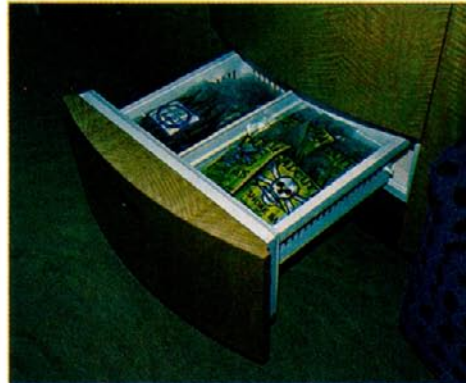
"Everything is holding up just fine," Evans told me, "particularly the slide-out refrigerator and freezer drawers. I was concerned that their slides were not beefy enough, but so far, so good—even our interior bait freezer, which is usually filled with about 100 lbs [45 kg] of small and medium ballyhoo and split-tailed mullet rigs. I rigged the galley and cabin drawers with the best Accuride stainless steel slides I could find, and they're working fine, too. We try not to open the bait freezer when we're thrashing around," he added, "but I'm sure it's going to happen someday. And then we'll know for sure about the slides." **PBB**
